Towards sustainable Utilization of Lake Chamo Biodiversity Resources: Geospatial analysis of lake level Changes, Challenges and Opportunities, Ethiopia.

1Alemayehu Hailemichael Mezgebe, Ethiopia. 2A.J. Solomon Raju Andhra University, India

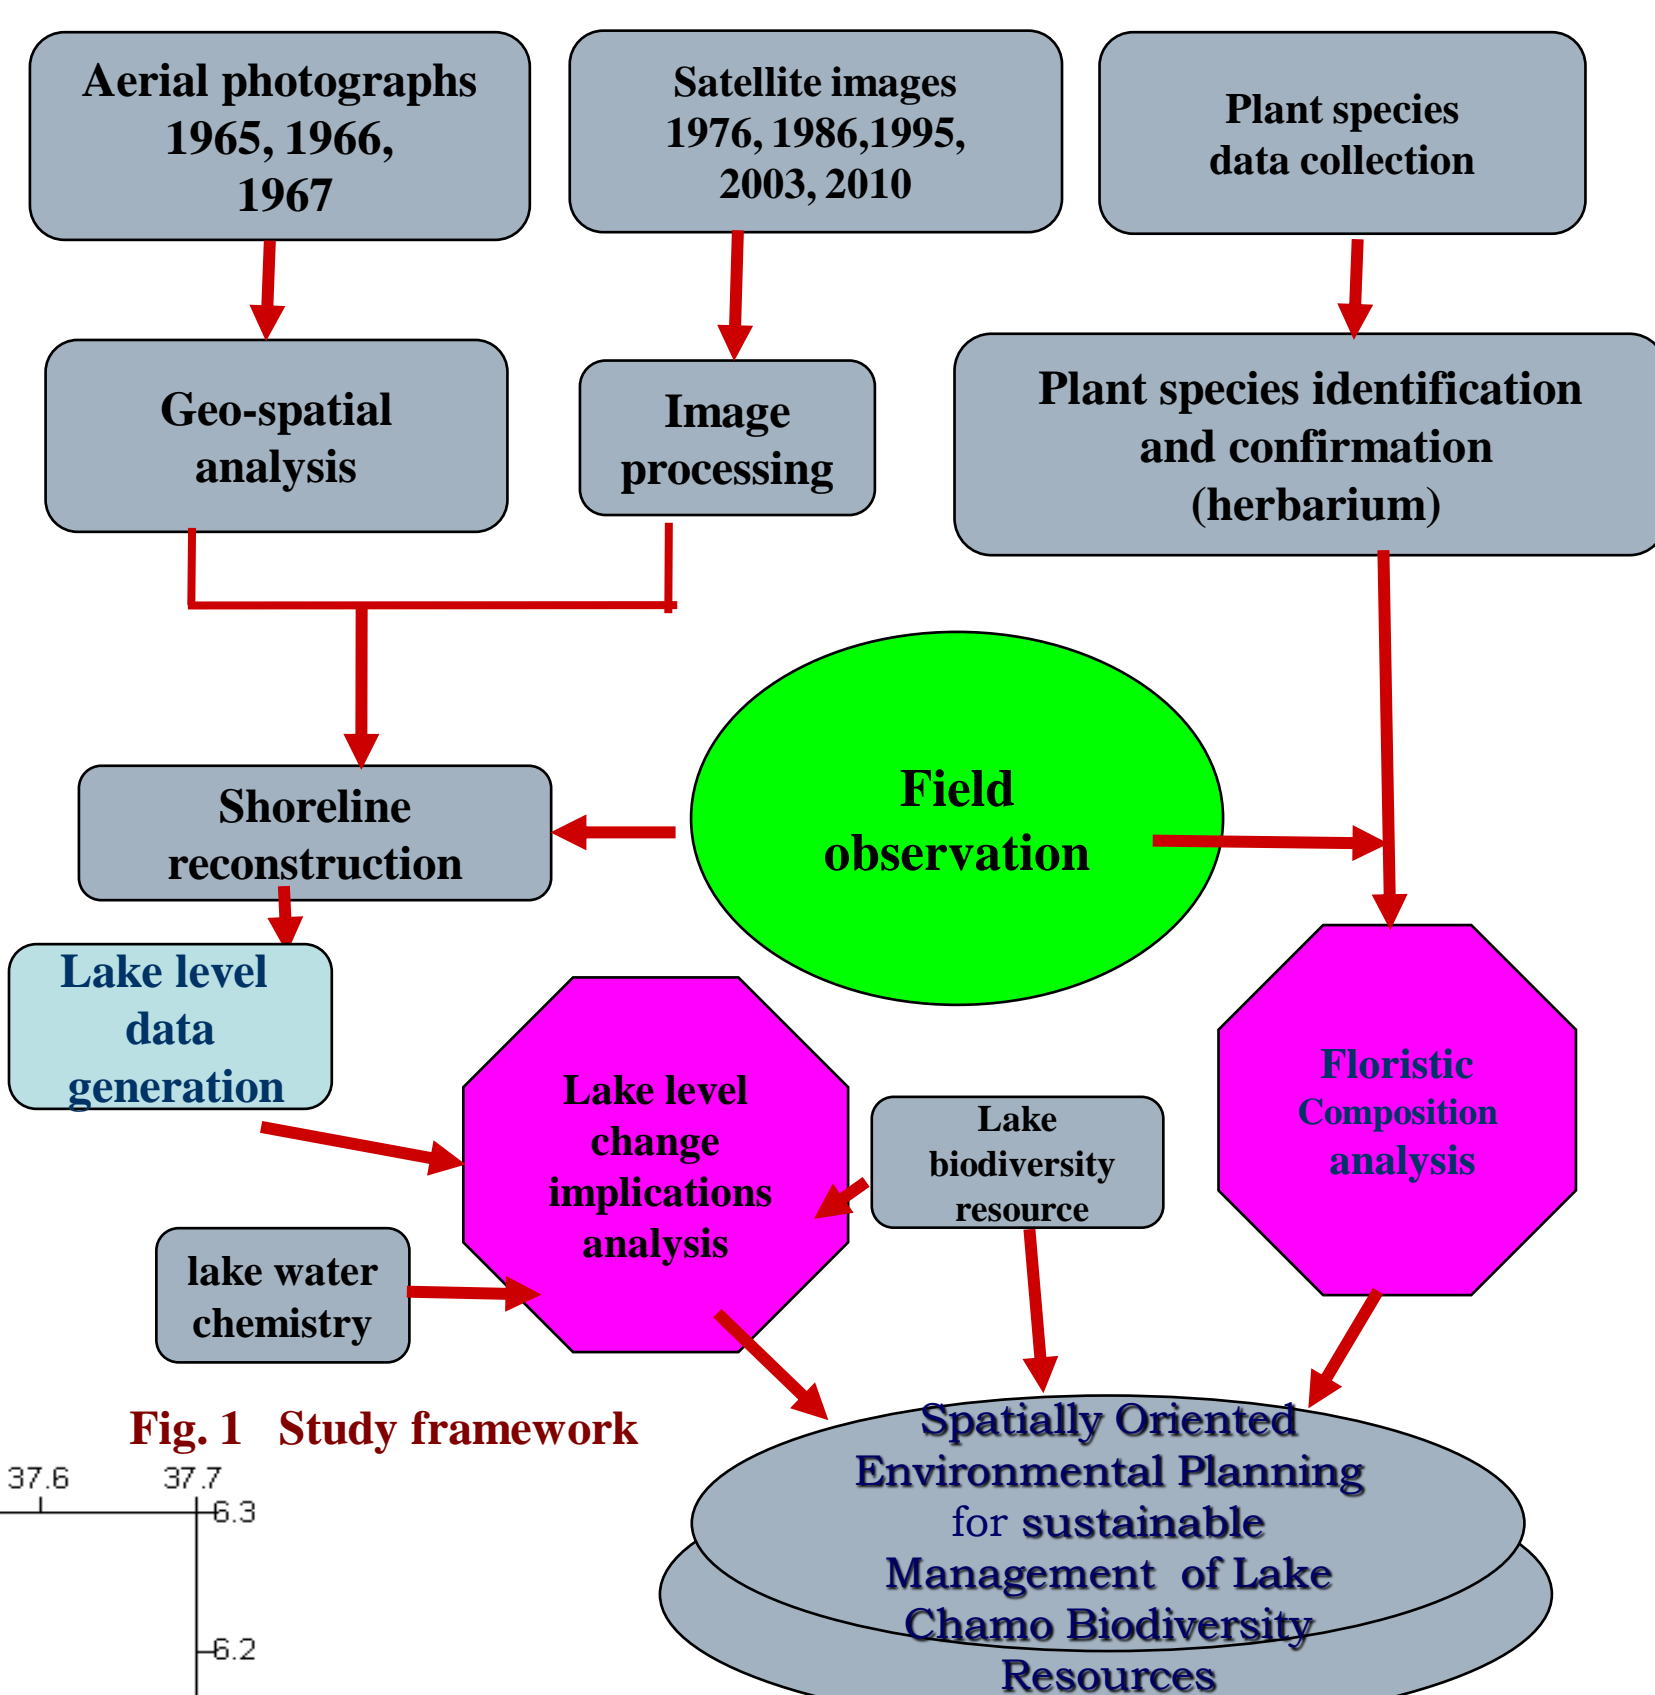
Fig. 1 Study framework

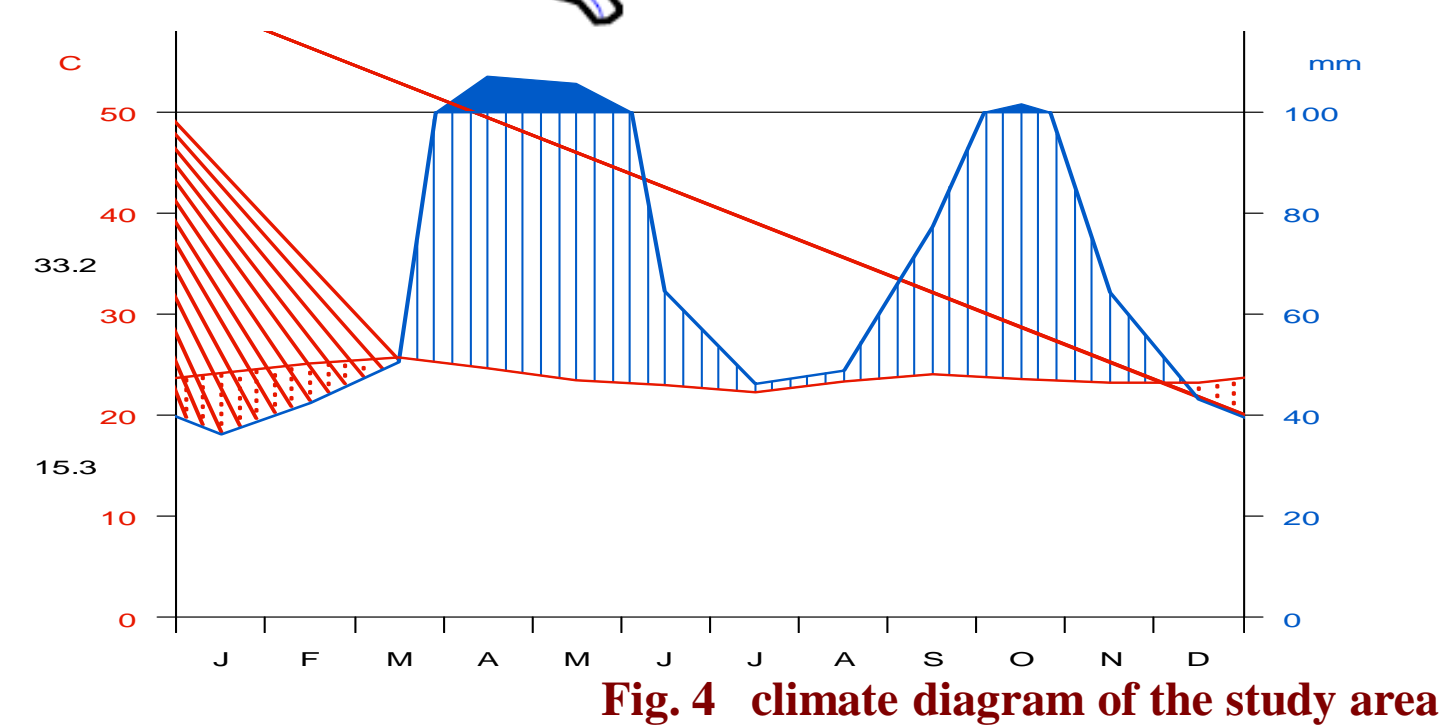
Fig. 4 climate diagram of the study area

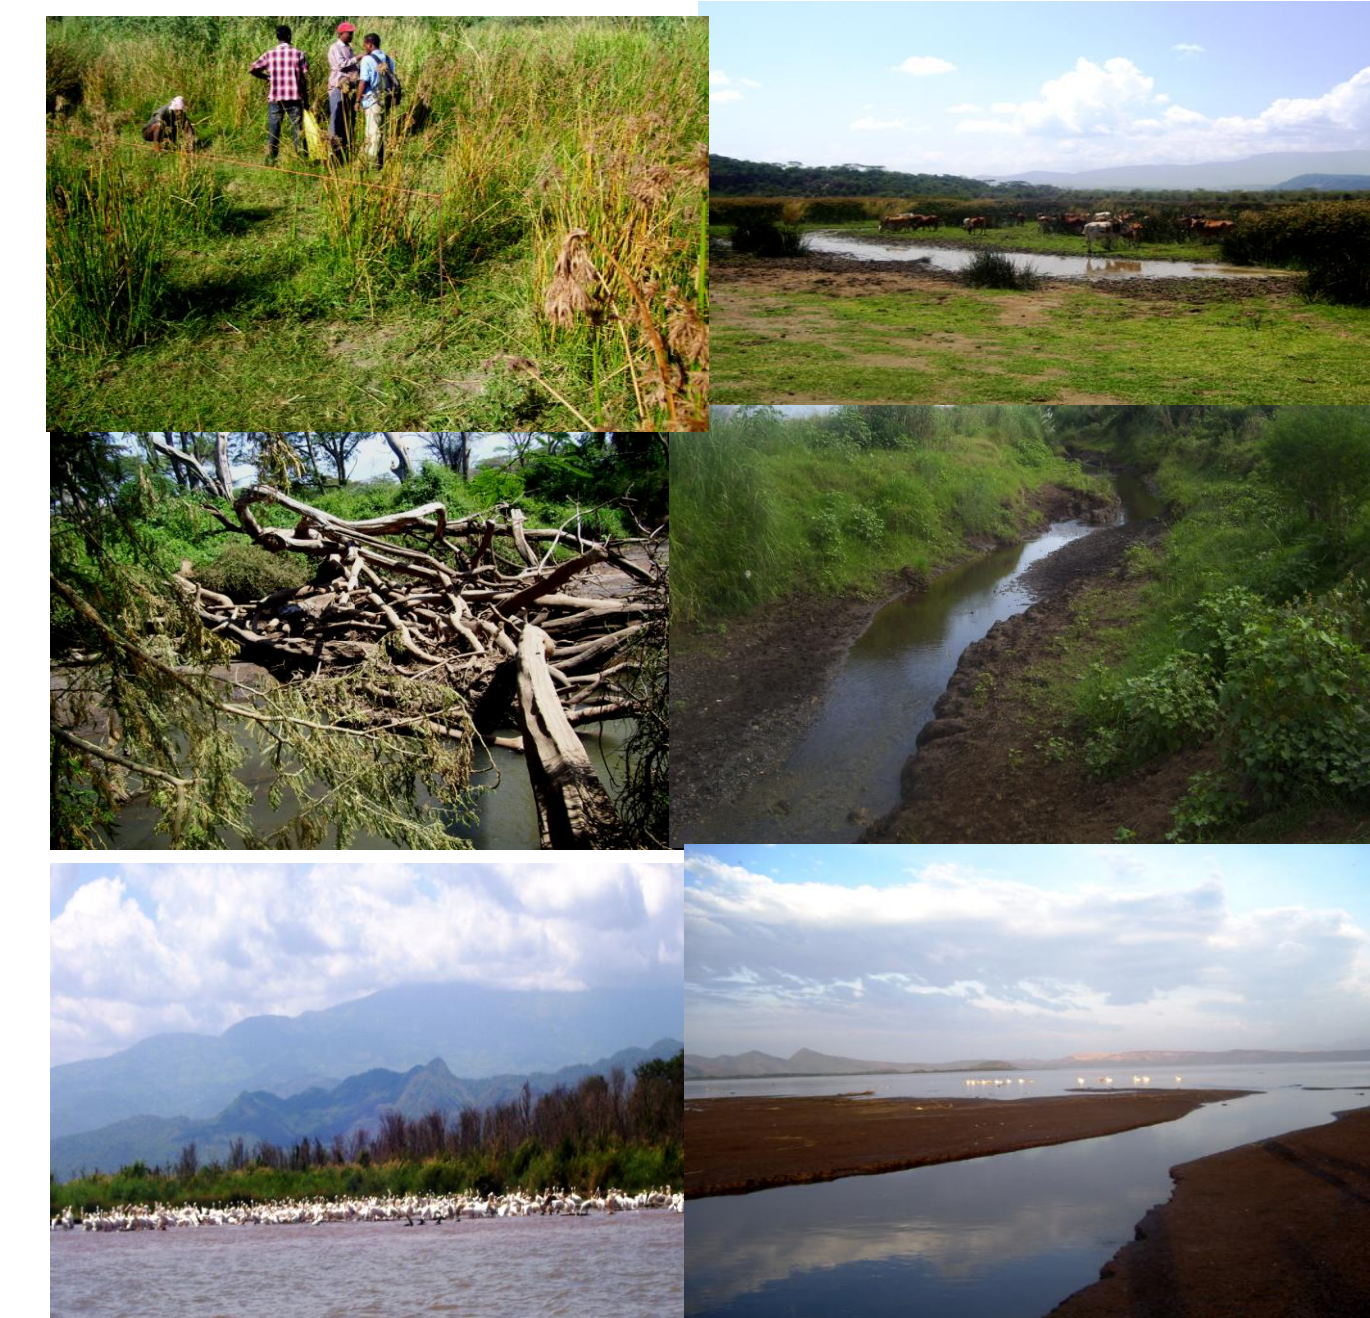
Fig. 9 Status comparison of Kulfo and Sille rivers

On the other hand, the encroached portions of the lake outskirts have lost the vegetation cover because of farming, grazing and clearance of the vegetation cover (Fig. 9)

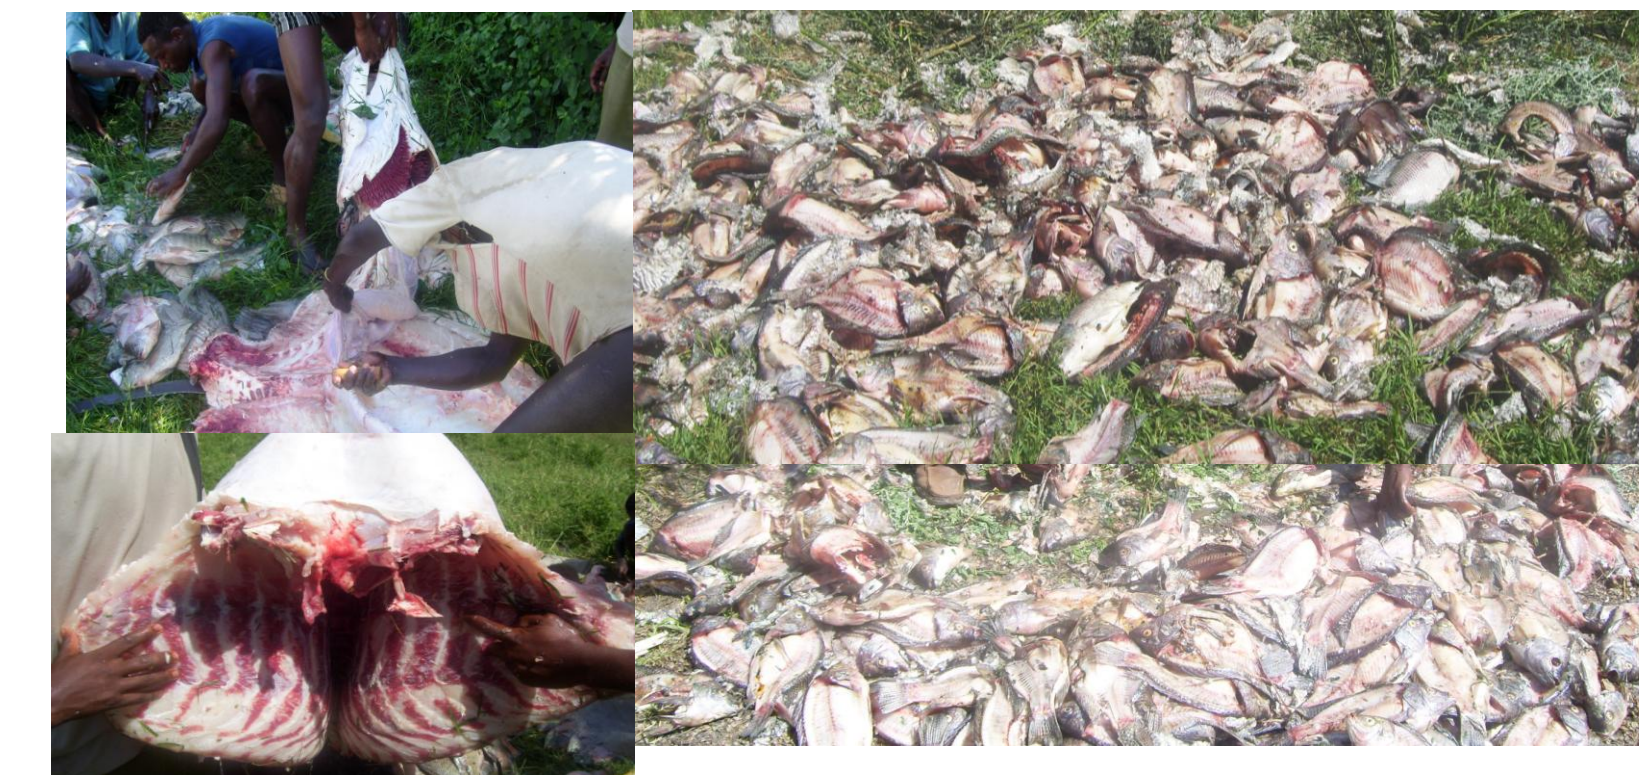
Fig.11 Lake side waste dumping practice of fishermen

- Lakeside waste management**
-Lake side filleting is another problem by fishermen (Fig. 11).
-Depletion of dissolved oxygen and toxic gas secretion up on decomposition.
- Over-fishing and Destructive fishing**
• Non-sustainable fishing practices prevailed in the lake
• The number of gears deployed were larger than the recommended.
• The average mesh size of nets is below the minimum recommended size which leads to destructive fishing.
- Car Washing**
• Vehicle washing practices along Kulfo river.
• The grease and detergents along with dirt have significant pollution potential to the lake.
