Several Measures to Enhance the Forest Function of Preventing Natural Disasters

Forestry Agency

Private Forest Department Forest
Planning Division

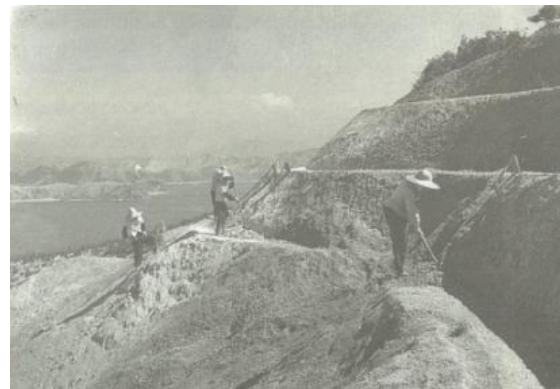
Under the work (Stair Slope Work)
(around 1953)

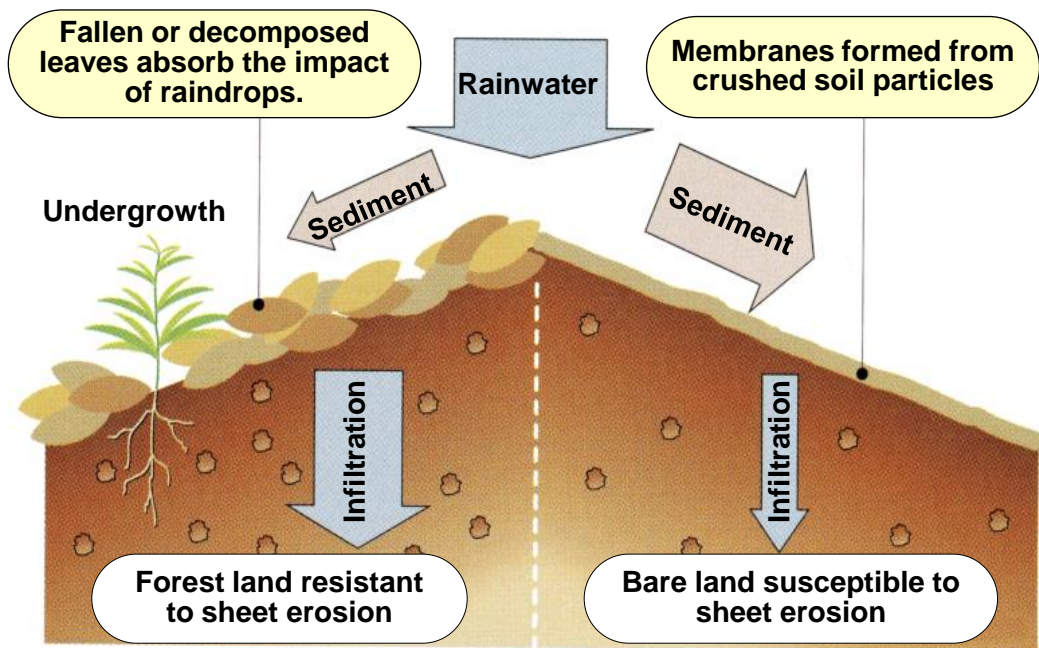
Function to prevent sheet erosion

Forest land prevents sheet erosion and sediment discharge

Comparison with the condition above ground

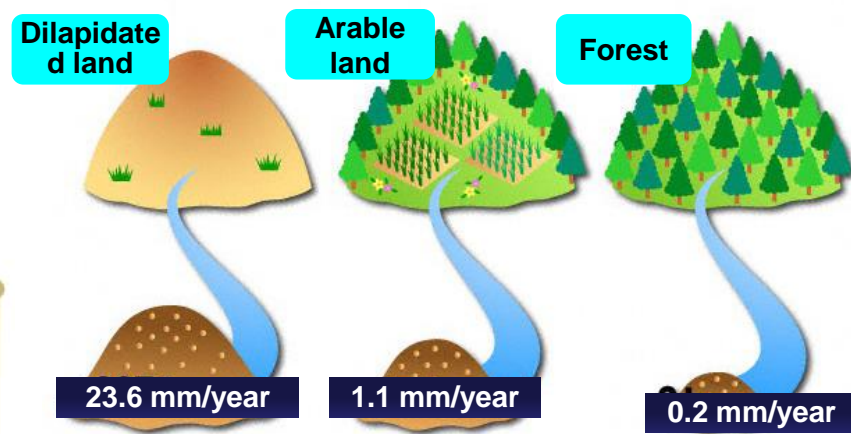
(cf.) Comparison of average annual erosion depths

Note: These values are the average of those measured values of erosion that are for slopes of 13° or over.

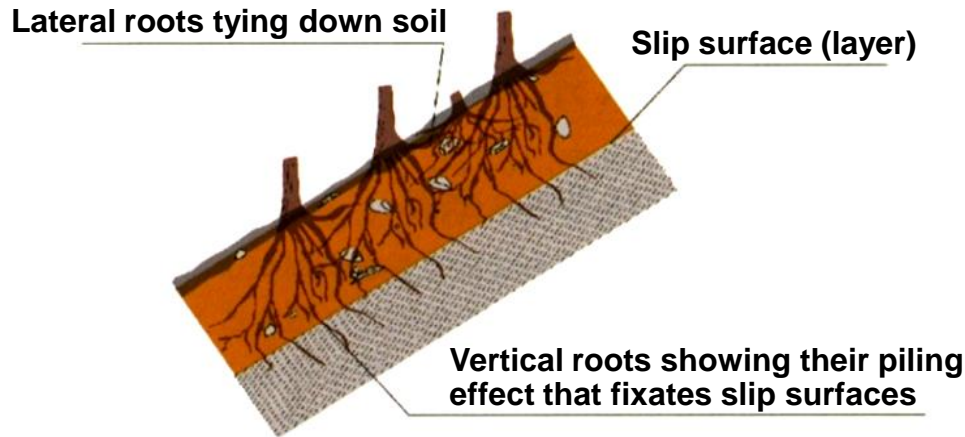
Roots grip shallow soil and prevent shallow landslide

Effects of lateral roots and vertical roots

Schematic illustration of the uplift resistance of roots (revised from Kitahara, 2006)

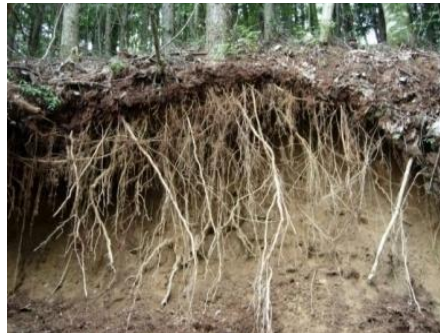
Forest not thinned on a timely basis

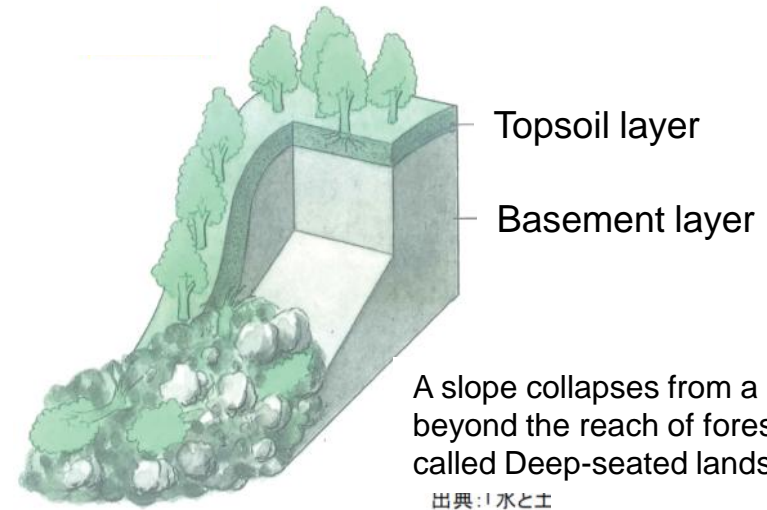
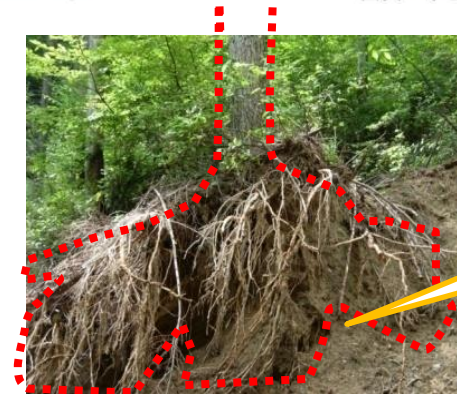
Appropriately thinned forest

Thinning thickens roots, which activates root swelling.

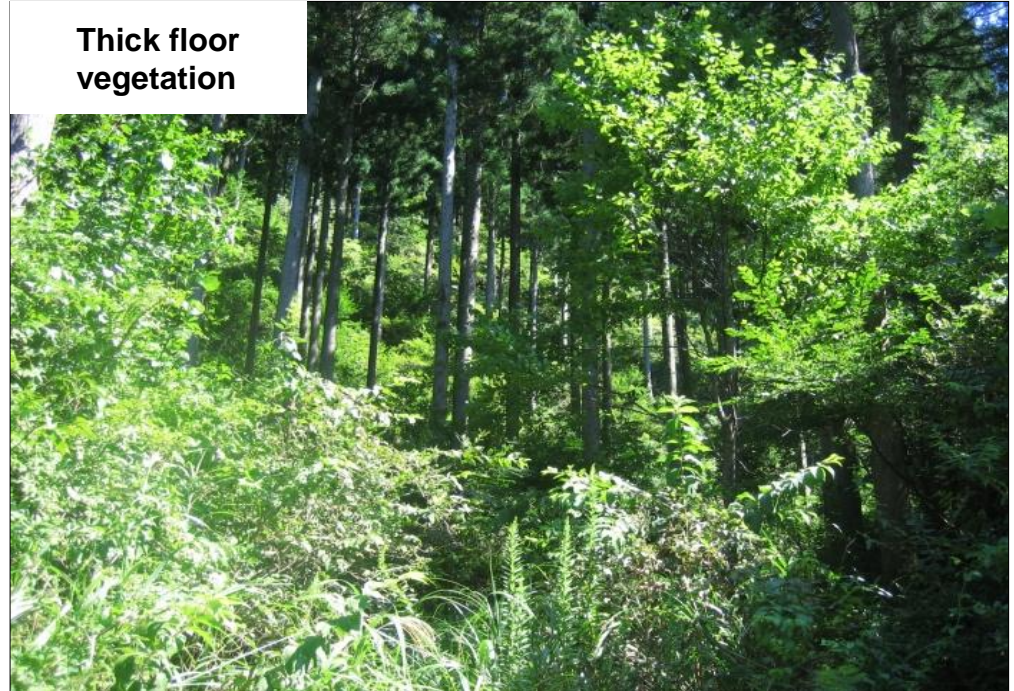
Thick floor vegetation

- Thick floor vegetation prevents sheet erosion.
- Growth of trees and roots prevents shallow landslide.

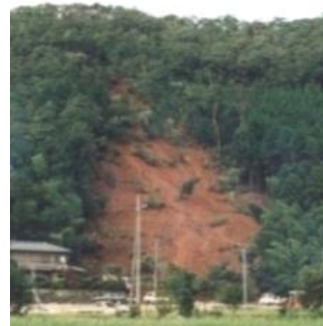
collapse(1996)

○ Facilities intended to stabilize the mountain slopes, including landslide protection work and vegetation work are laid out appropriately to match the characteristics of each failure so as to promote sure restoration of forests.

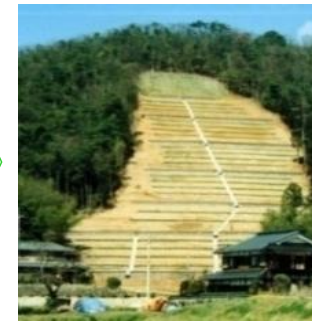
Immediately after the work (1998)

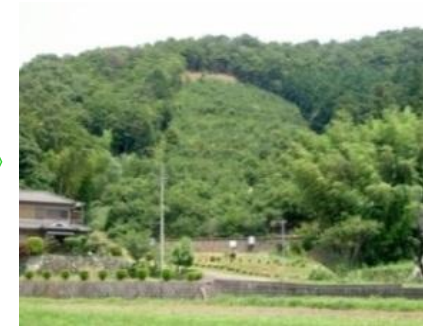
Around 10 years after the work

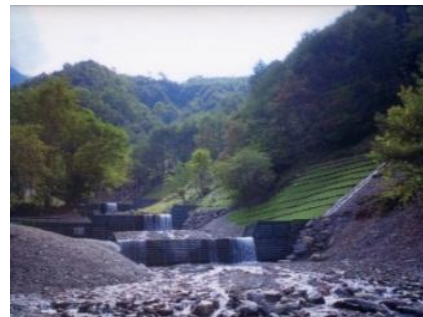
◇ Stream Work

○ Construction of erosion control dams and other facilities prevents erosion of banks and beds of mountain streams and stabilizes the foot slopes thereby to ensure the growth basis of forests.

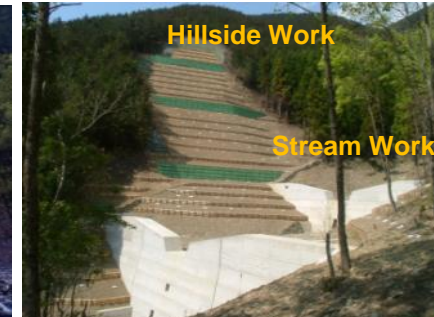
◇ Combination of Hillside Work and Stream Work

Sediments deposited and stabilized

↑ Figure with the mountain stream seen from the side

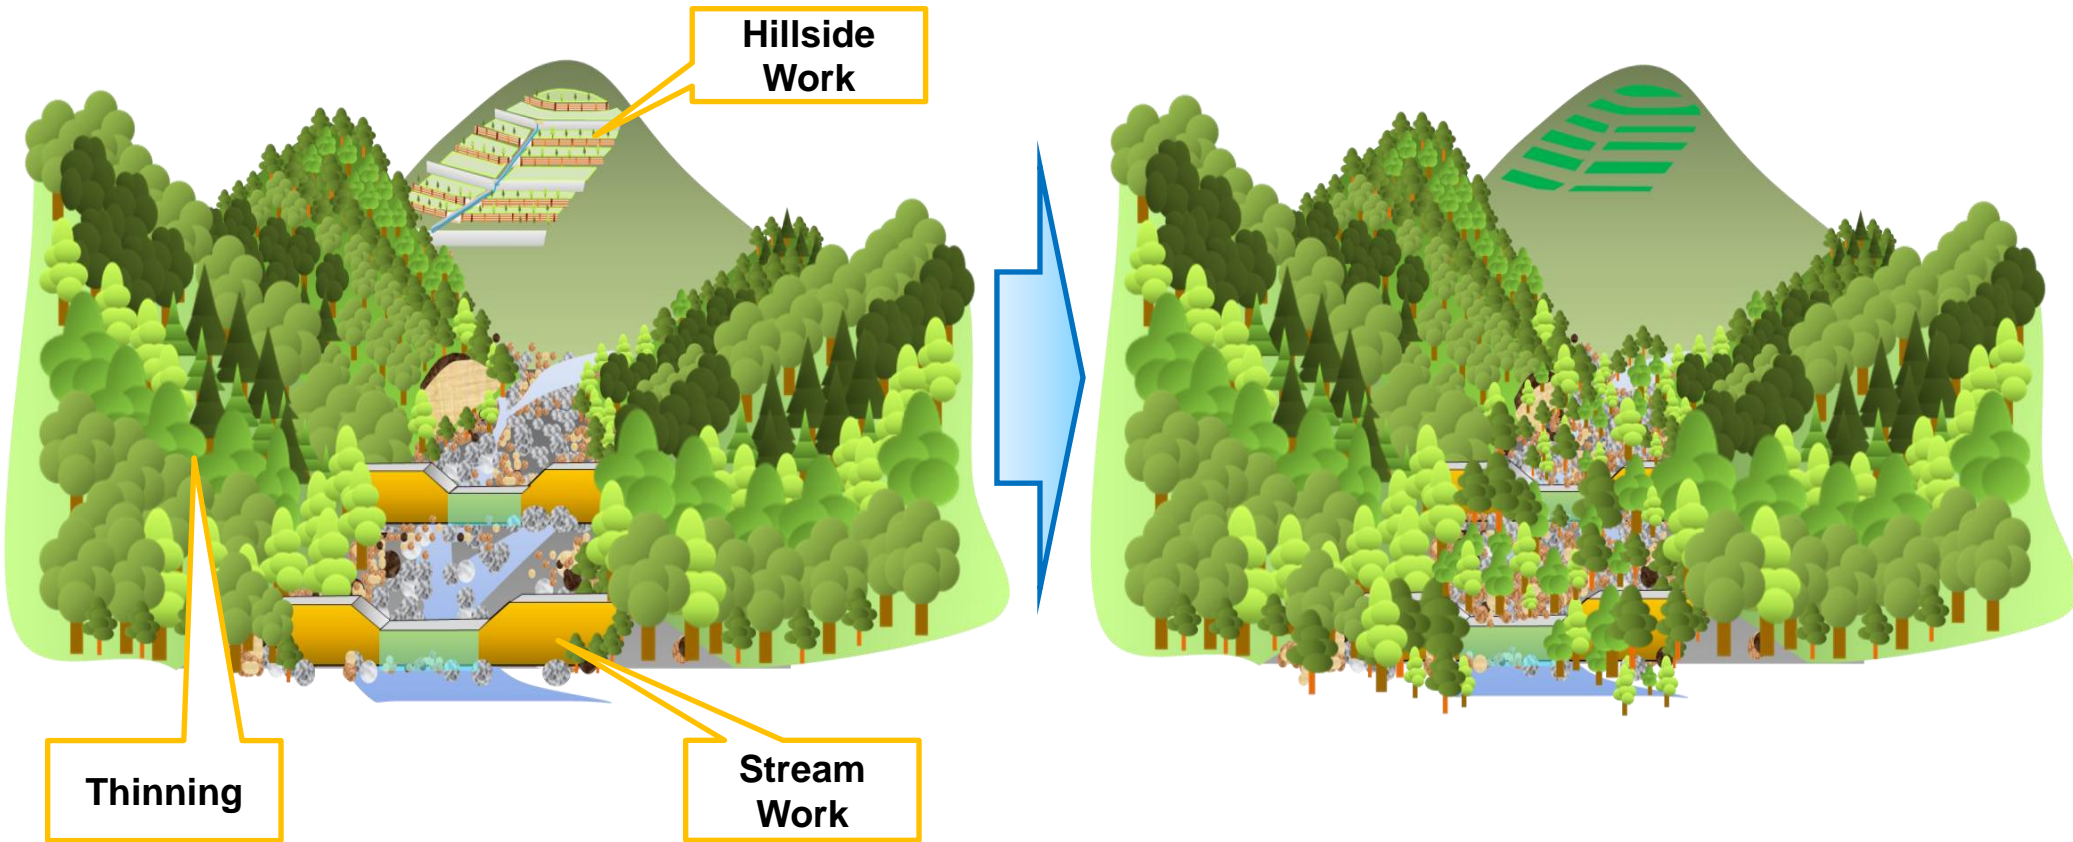
- In order to improve preventive functions of forests, it is important to design erosion control projects and forest improvement activities as a comprehensive program.

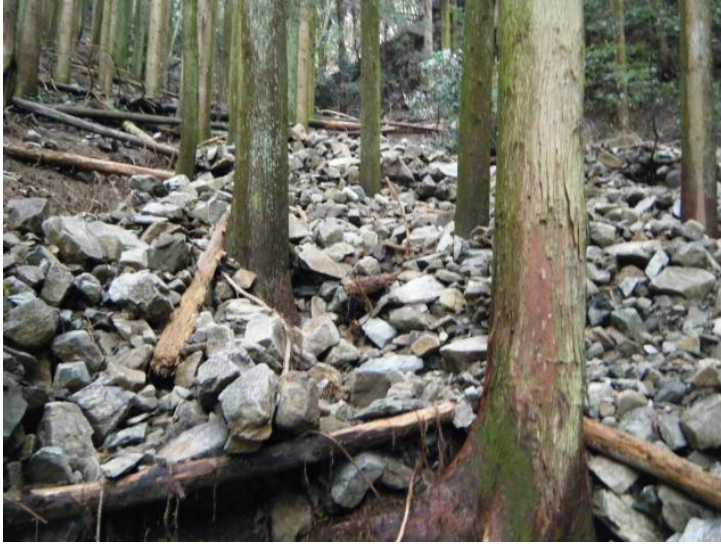
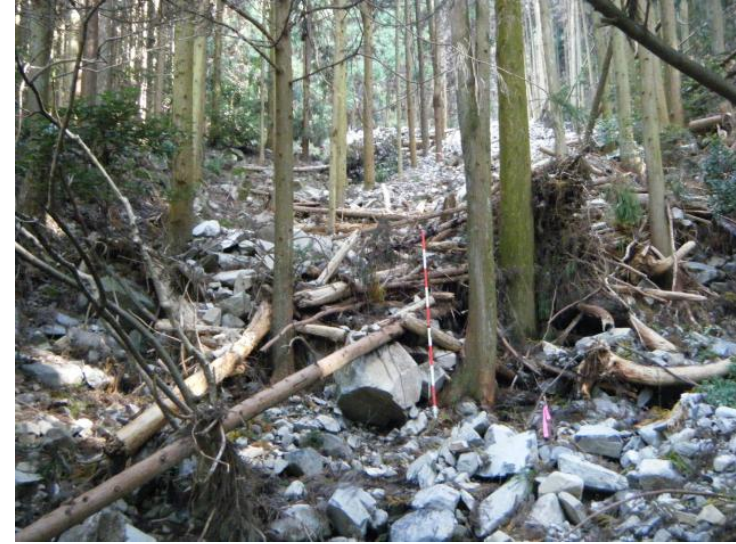
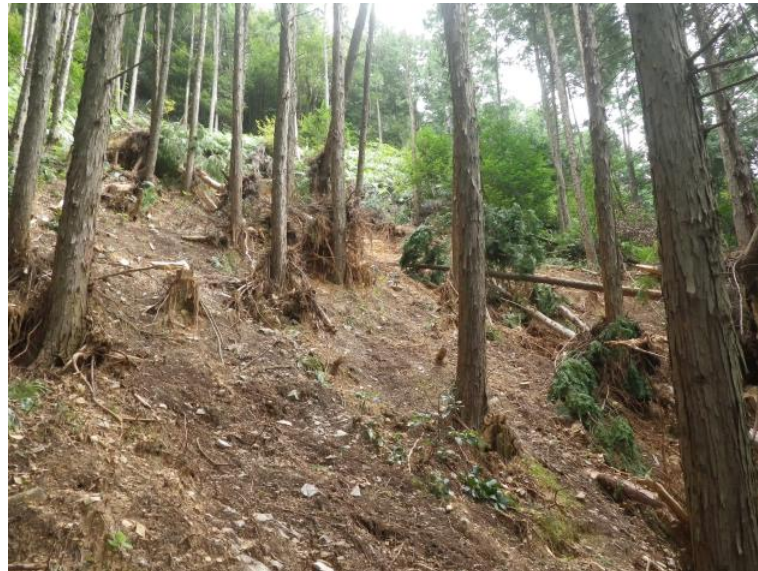
- Forest trees captured rocks and driftwood from debris flow at the heavy rain disaster in HIROSHIMA, August 2014.

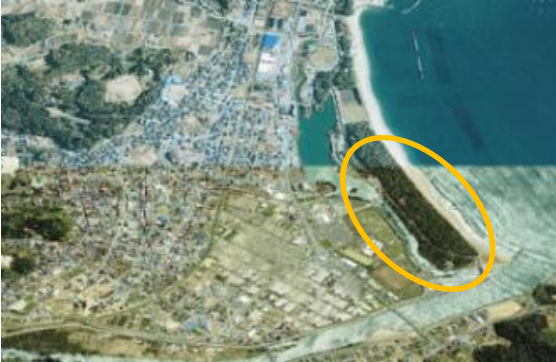
- Whole forest was disappeared

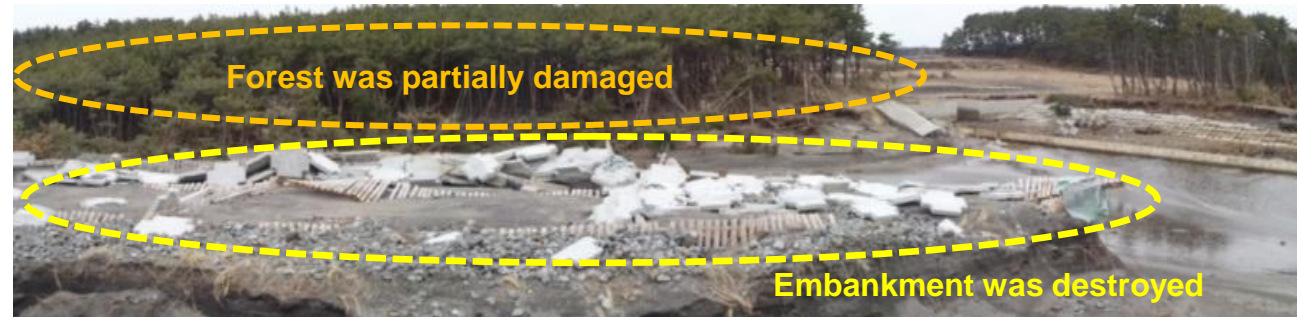
- Embankment and forest were damaged

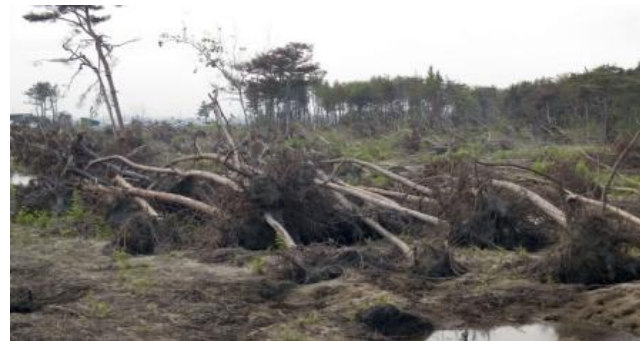
【Sendai City, MIYAGI】

- Damaged roots

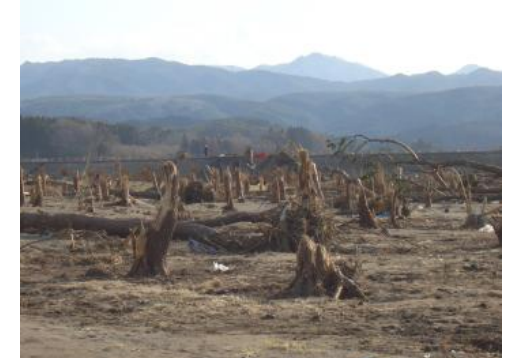
【Noda Village, IWATE】

- Damaged stems

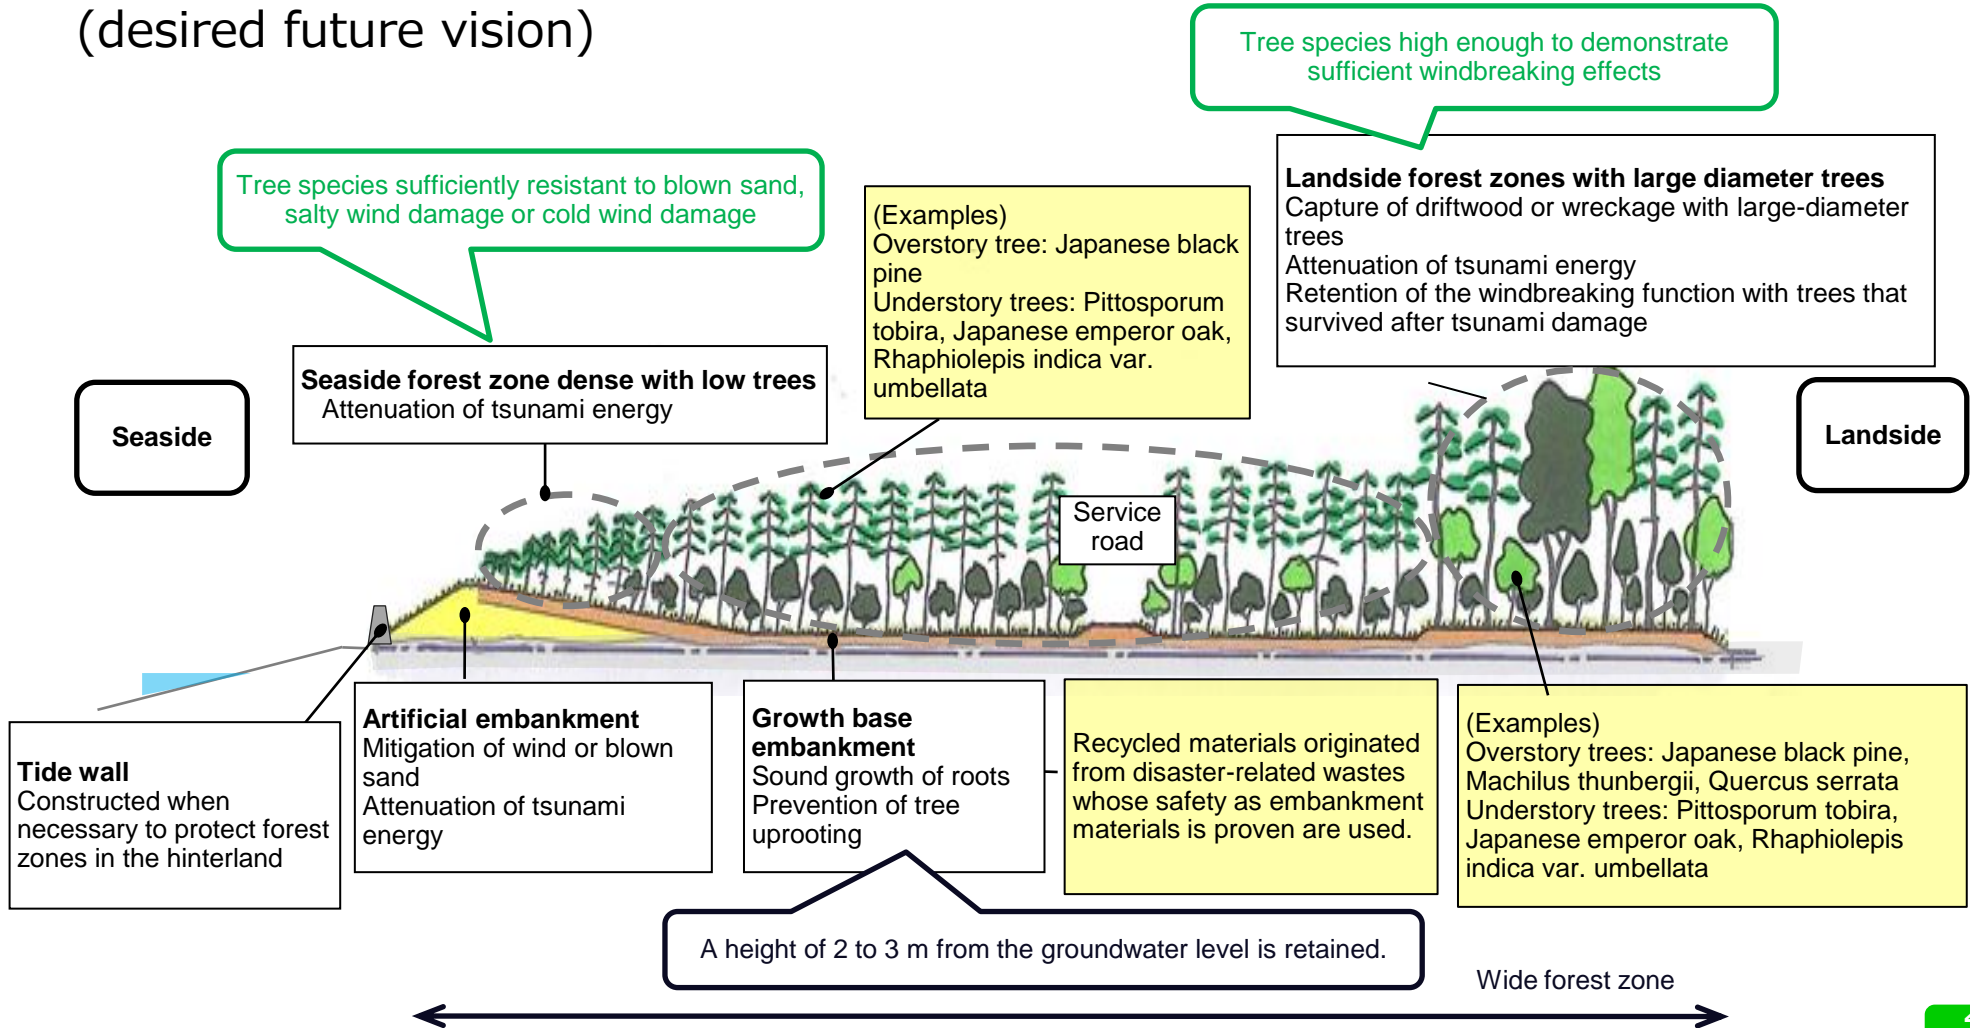
- The objective of restoration project is not only improvement of sand and wind prevention but also tsunami damage mitigation.
- Different measures are chosen for each damaged coast taking into consideration of geographical, ecological and social features.

■ Schematic illustration of restoration of coastal protection forest (desired future vision)
